## Fuel Tank Vent Line Leak – Sharing another Experience

By Hugo Ritzenhaler

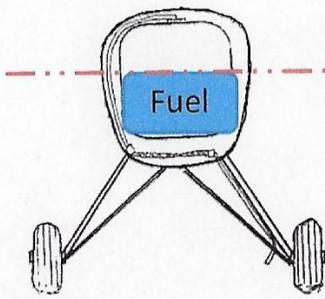
Fig. 2 Fuel in tank will not enter the vent line

## Up-Right Flight

No Spray

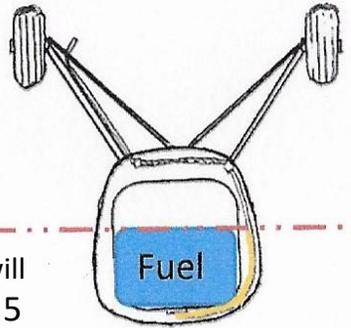
Fig. 5

## Inverted Flight

No Spray

Fuel in tank will enter the vent line, but will remain in the ALU tubing

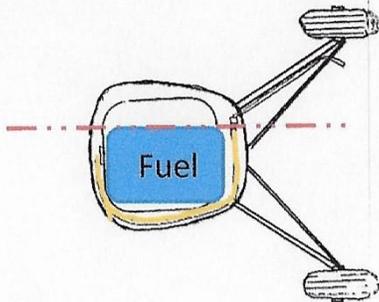
Fig. 3

## Knife-Edge Right Flight

Spray

Fuel in tank will enter the vent line, but will also enter the braided flex hose

During the root cause analysis it was important to evaluate the g-force acting on any fuel having entered the vent line. In case of Fig. 3, one would not expect any appreciable g-force during a slow roll. An inverted turn would produce negative g's.

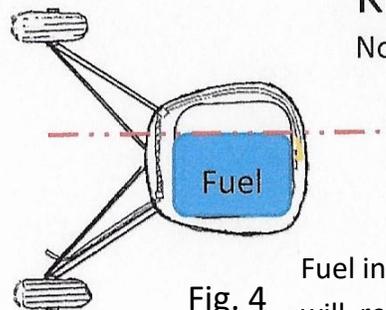
Fig. 4

## Knife-Edge Left Flight

No Spray

Fuel in tank will enter the vent line, but will remain in the ALU tubing as long as tank is not completely filled

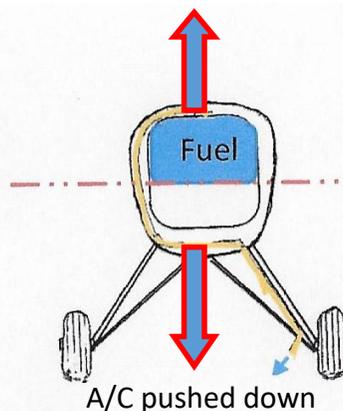
Fig. 6

## Push-Over > -2g

Spray

Fuel in tank will enter the vent line, but will also enter the braided flex hose

However, since most of the sprays that I encountered were at the top of a pull-push-pull Humpty (Fig. 6), it was this scenario to be closer looked at. Any fuel having entered the braided hose portion of vent line would see a force up toward the pilot when subjected to negative g's. A damaged flex hose would cause a spray upwards. At this point, the flex hose was removed and checked for a leak. Our assumption proved to be correct, there was a leak close to the right side of the cockpit.

The braided flex hose was replaced with a fuel resistant clear plastic tube, which fixed this leak for good.
