EAA CHAPTER 1445
JUNE AVIATION ACCIDENT/INCIDENT SUMMARY
by Jim Timm
Arizona Pilots Association

The following are the reports of aviation accidents and incidents that have occurred in Arizona from late May, thru late June. APA will be using this detailed information to develop safety programs, briefings, and posters/flyers that would help pilots learn from the mistakes being made by others, and take the action necessary to prevent them from having similar occurrences.

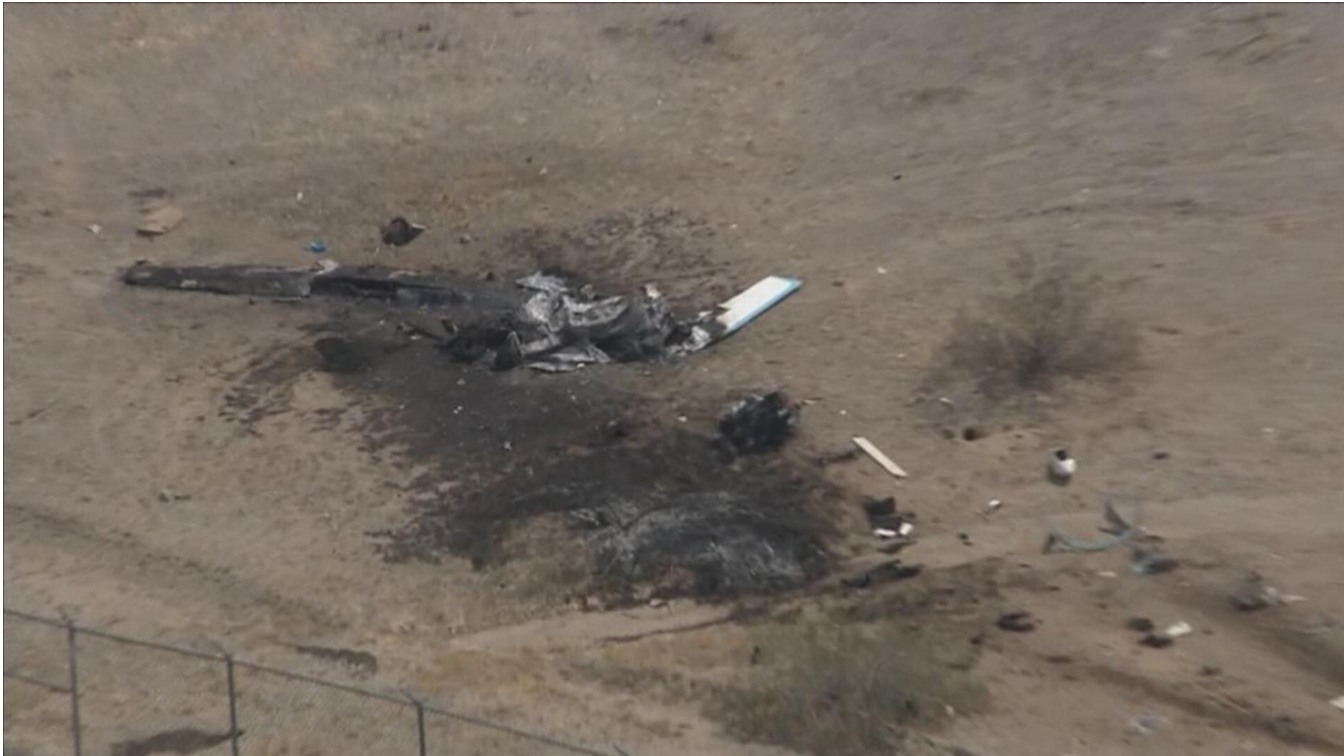
CRASHED AND BURNED ON TAKEOFF

The aircraft, an experimentally built QAC Tri-Q Quickie, impacted the terrain shortly after takeoff from Gila Bend Municipal Airport (E63). One person was ejected from the aircraft in the crash, and was airlifted to a hospital. The airplane was destroyed by the ensuing post crash fire and one of the two occupants onboard was fatally injured. The second occupant onboard was seriously injured.

The following is a picture of the June 15 Quickie Q2 accident at Gila Bend.
