JULY AVIATION ACCIDENT/INCIDENT SUMMARY

**by Jim Timm
Arizona Pilots Association**

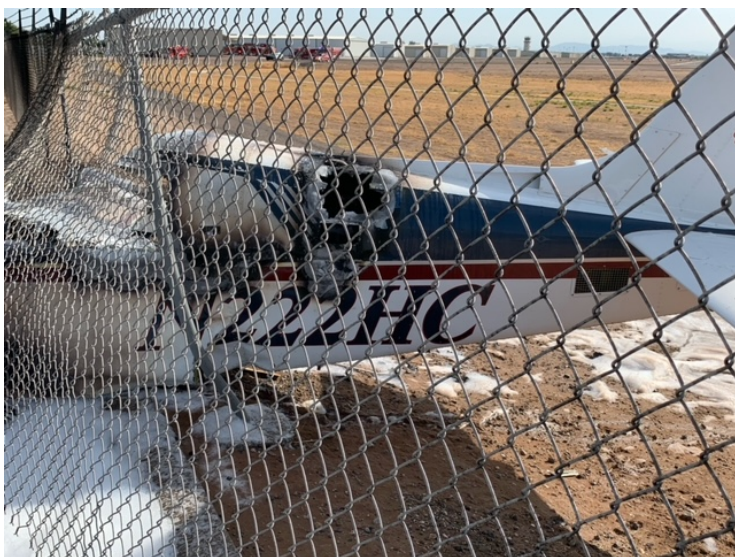
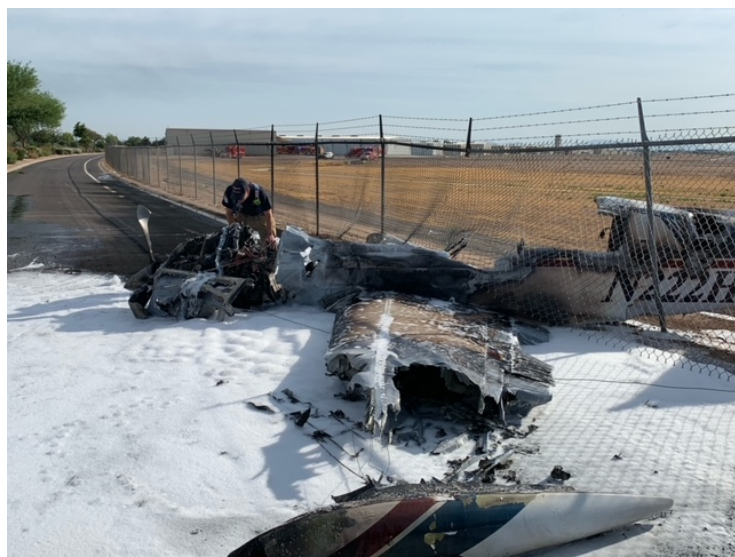
The aircraft was destroyed by fire subsequent to an impact with the airport boundary fence during a takeoff attempt from runway 22R at Chandler Municipal Airport (CHD). The airplane had been refueled and two couples had boarded the aircraft before takeoff.

The following pictures are of the July 10th accident at Chandler Airport of the Beech A36TC Bonanza that hit the fence and burned. The pictures were taken by Mr. Rich Fitschen.
