Raven Flight -Knock It Off-Lead Electrical Failure!

By Dan Berry Chapter 648 Technical Counselor

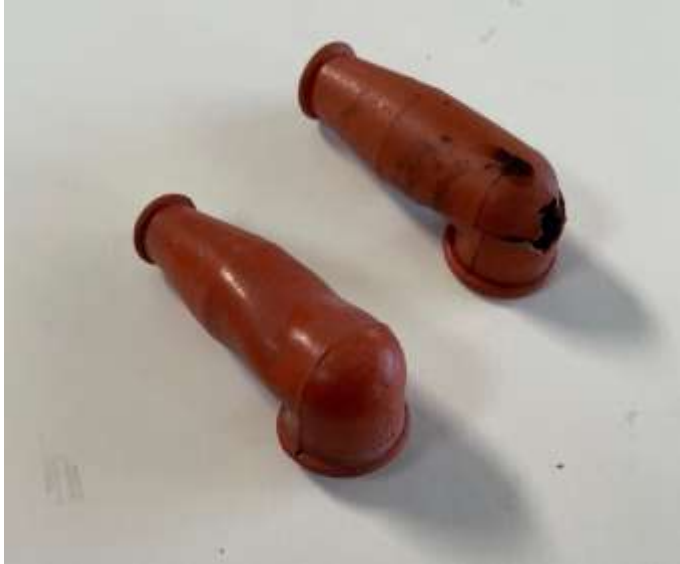
Upon further investigation I realized it was a hole. It made no sense that the cowling rubbed a hole in the boot, I knew I had plenty of clearance with 675 hours and many conditional inspections with this configuration.

The B-Nut vibrated loose, opening a gap between the B-Nut Stud Nut and the Wire Terminal End. This allowed arching and sparking to occur, every spark burned metal from the stud until it broke off, a very effective arch welder/plasma cutter event. The boot contained the sparks until it burned through.

Upper Boot with Burn Through compared to the lower New Boot

My current installation now has a split washer, required torque AND I added a strip of Torque Stripe Seal to visually inspect any movement of the hardware stack all under a new electrical terminal boot.

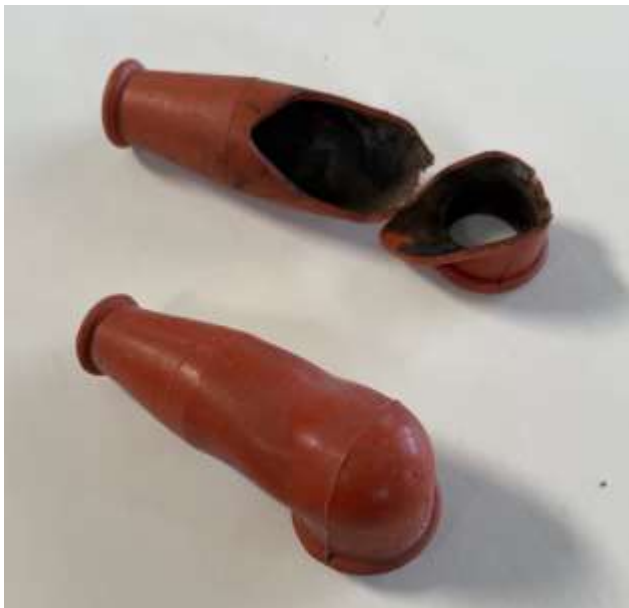
I pulled on the boot and it crumbled in my hand along with a nut attached to the burned off battery buss output post threaded stud. The hole was from a burn through event.

Looking inside the burned metal inside the boot

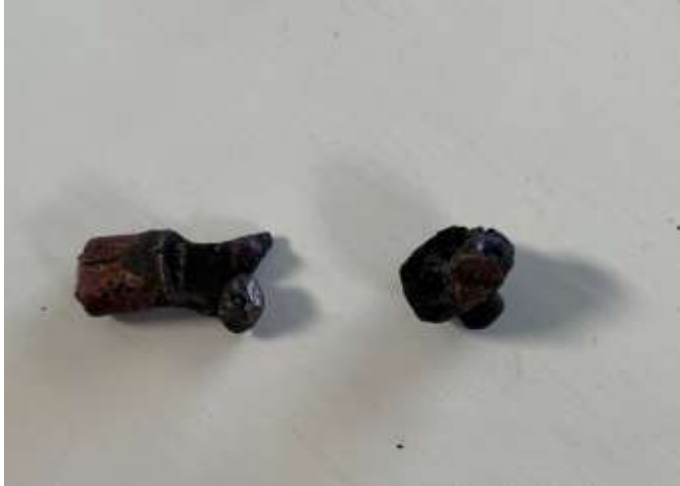
The melted away Wire Terminal, Stud and Nut

The instructions for the L40 simply say "Install the large gage wire from the Battery Master Contactor on the copper post labeled "B". This is often referred to as the BNut. No torque values declared and no lock washer supplied.

Hartzell Alternator Models ES-6904 Owners Manual requires inspection for Arc Marks near the BNut/Output post AND requires a Split Lock washer in the hardware stack with a torque of 40-50 In-lbs.
