Flight Control Problem – Sharing another Experience

By Hugo Ritzenthaler

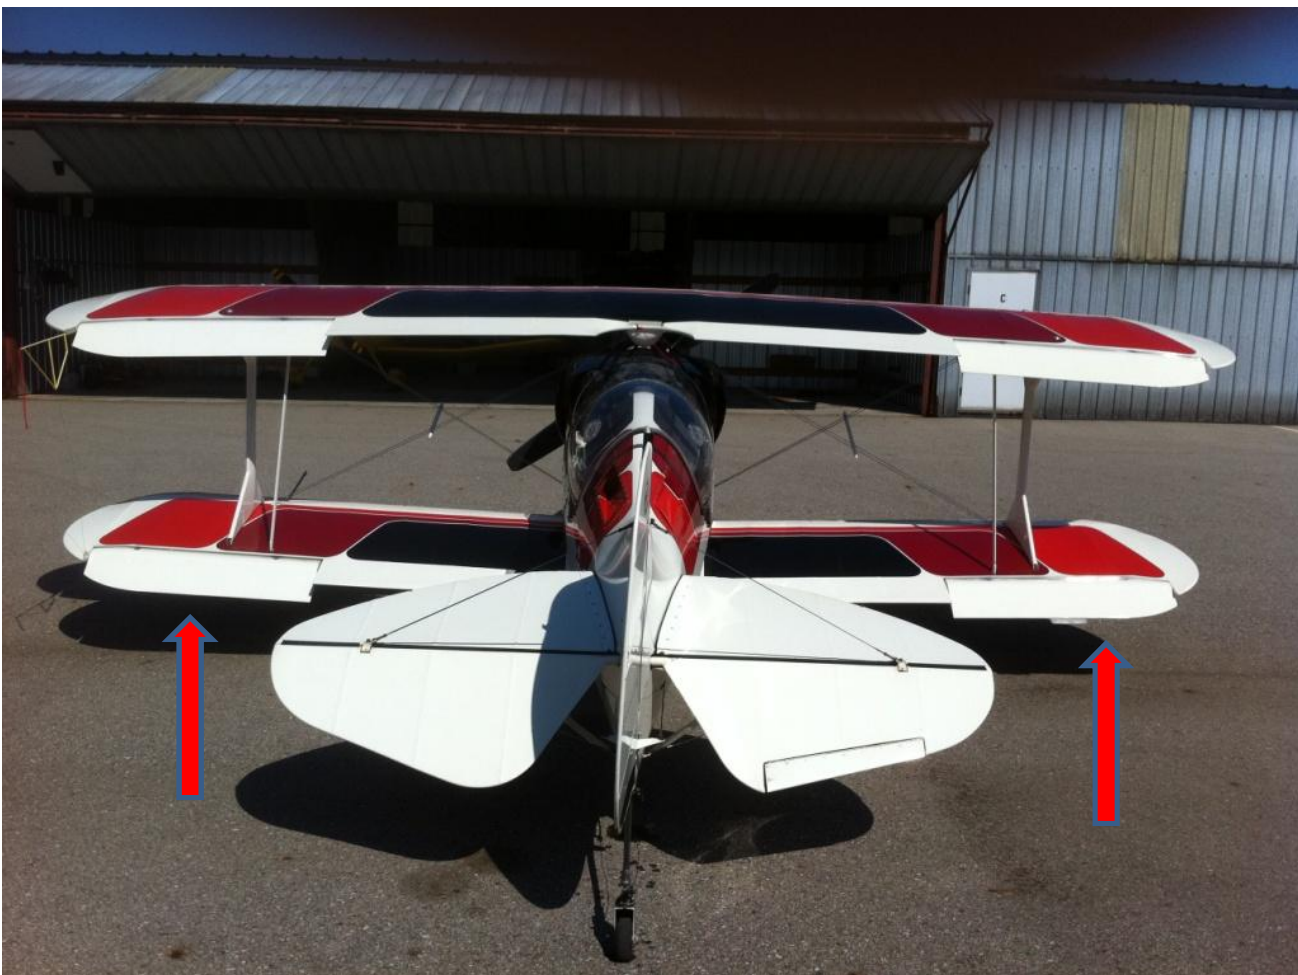
While practicing my Unlimited Free sequence, somewhere in the midst of the sequence, I started a 360 roll and immediately encountered extremely heavy stick pressure, making it difficult rolling the Pitts around. Back at level flight, I was able to rock the wings. I looked out at my wings but could not see any damage whatsoever. Another try to roll the Pitts resulted in the same high stick input pressure. No doubt, something did go wrong during this practice flight, so it was time to get down onto solid ground. Flying the typical landing pattern, my aileron input pressure was pretty much normal. I landed safely and taxied back to my hangar. It was there after engine shut down, that I got a hint for having encountered the high stick pressure input. With the engine shut down, all four ailerons pointed downwards. While moving the stick side to side only the left top and bottom ailerons responded. Obviously, I had lost control of the top and bottom aileron on my right wing.

Position of ailerons upon engine shut down

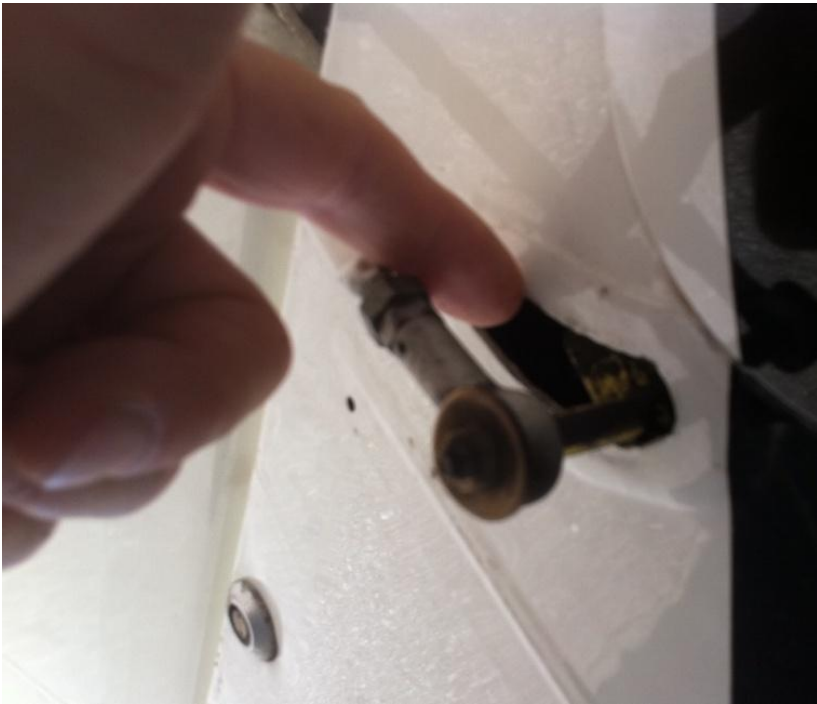
It was time to carefully inspect the right aileron control mechanism. A simple check of the underside of the lower wing pointed to the slave rod assy, which was loosely hanging out of the wing. This bolt is normally attached to the bell crank and the slave rod of the lower wing. The slave rod connects to the slave strut that controls the upper wing aileron.

Slave rod assy loose and hanging down

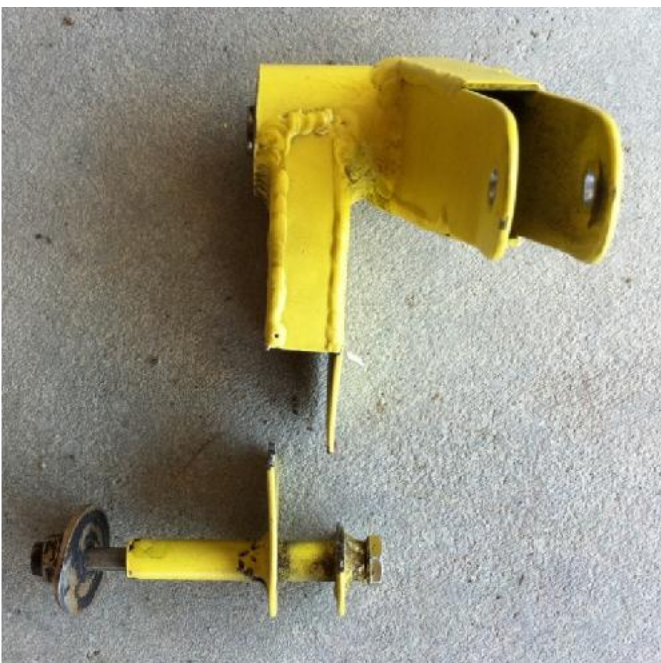
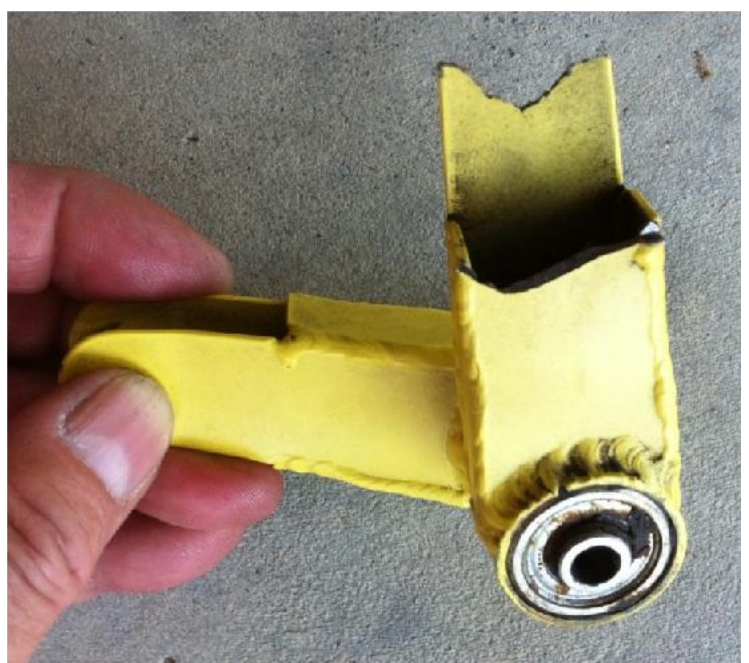
I suspect that one of the flanges had fractured some time before, so it was only a matter of time until the second flange tore off. As I remember, during flights before this day in September, the roll rate had slightly deteriorated. Reason for that was the bending of the second flange causing a reduction in aileron deflection.

Removing the bell cranks is not an easy job, as it requires cutting a hole into the fabric at the top side of the lower wing in order to remove the long bolt which connects to the slave rod at the outside of the bottom wing.

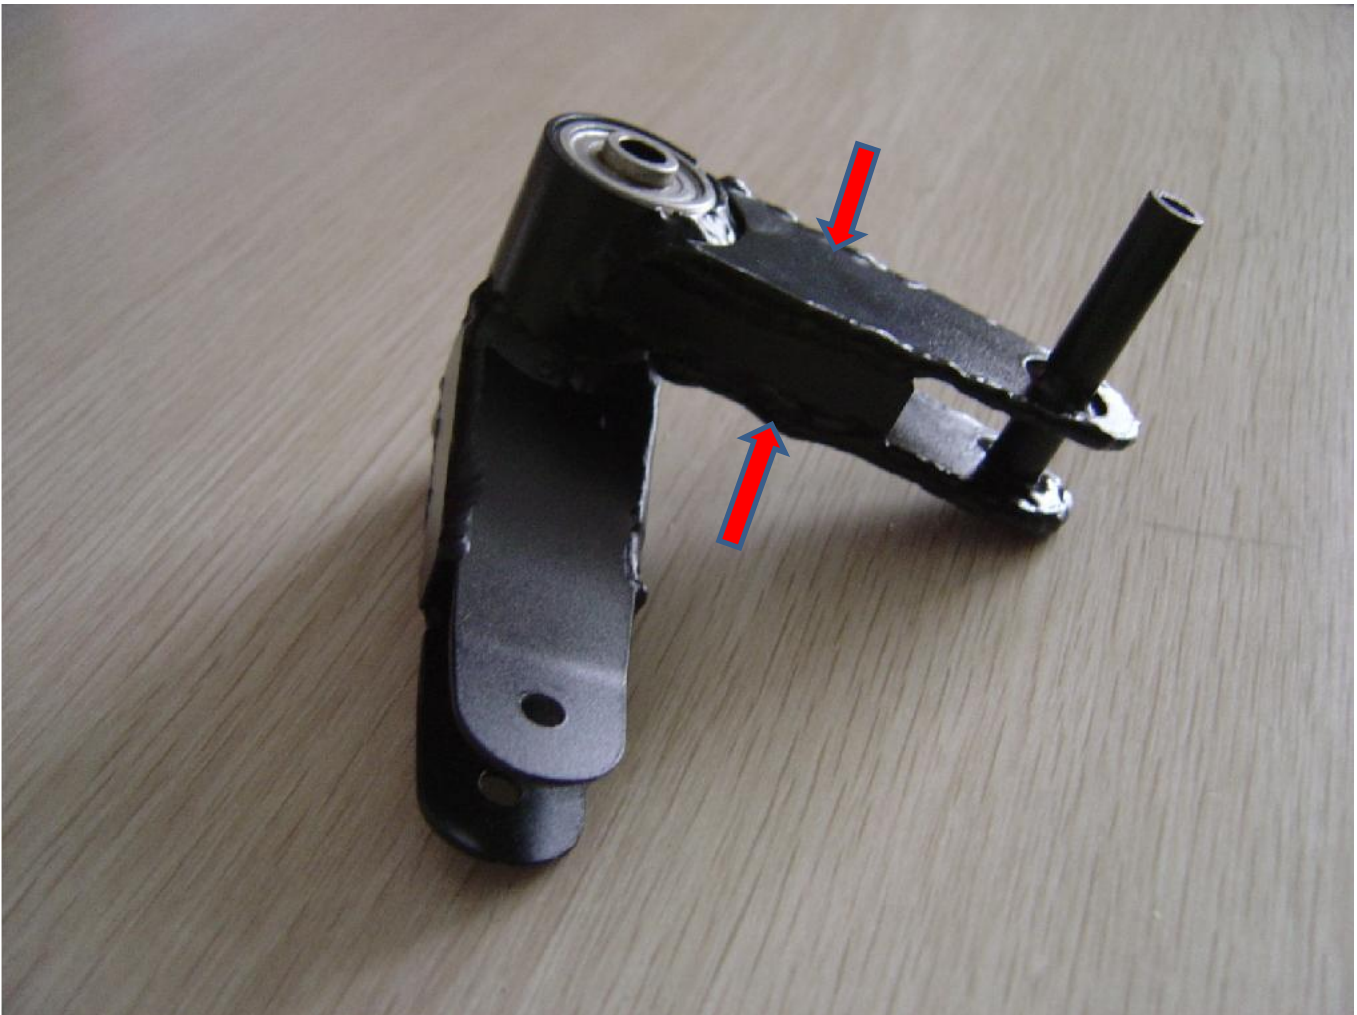
Reinforced bell crank: addition of another flange at each side

Knowing well that the bell crank at the left wing could break anytime, too, both bell cranks were reinforced by welding a second flange to the top and bottom of the existing flanges.

After reinstalling both reinforced bell cranks and performing some test flights in the vicinity of my home airport, I restarted my practice flights and competed in another IAC competition in Bellefontaine, OH early October 2011. In 2013 the top and bottom wings were opened up as part of a general overhaul of this Pitts. This provided a perfect opportunity for inspecting the reinforced bell cranks close up. The bell cranks were found in excellent condition. As of this date, November 2020, the reinforced bell cranks have performed flawlessly.
