# Cracked Torque Tube – Sharing another Experience

By Hugo Ritzenthaler

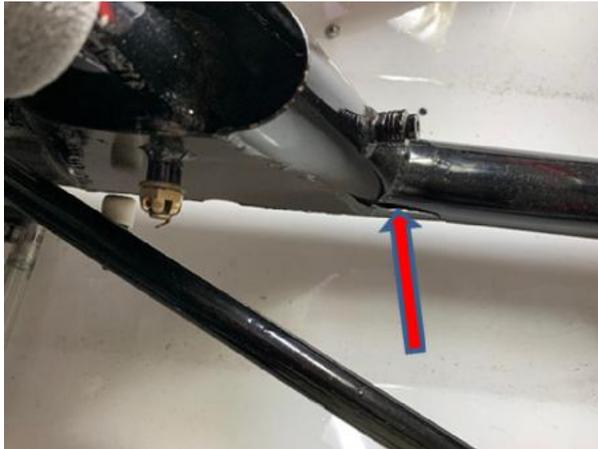
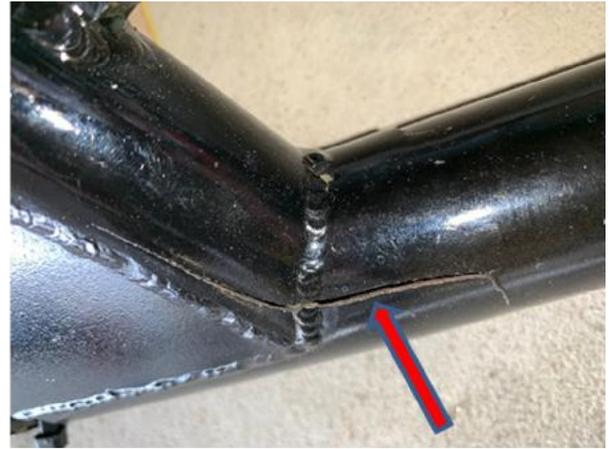
When I inspected the Pitts, clamped down the ailerons and moved stick sideways for aileron input I heard a squeak. Looking at the side of the torque tube, one could see a crack opening while moving the stick.

Gap opened near weld line when forcing stick to side with ailerons locked (clamped down)

Removing the torque tube was a big job. The way the airplane was built, there was never a thought that the torque tube would ever have to be removed. The torque tube was constructed in accordance with the original Pitts specifications, which calls for a 0.35" material thickness. It did hold up for a total of 998 hrs of operation, 480 hrs of them were flown in the Unlimited category. Considering that some of the reported torque tube failures (with 0.28" material thickness) occurred between 400 and 550 hrs Total Time, the assembly in my Pitts held up quite well.

Upon removal of the torque tube, two reinforcements were added. A gusset was welded on top of the tube connecting the tube with the stick tower and a channel was welded at the bottom of the tube where typically a crack can incur.
