Airspeed Indicator Anomaly – Sharing another Experience

By Hugo Ritzenhaler

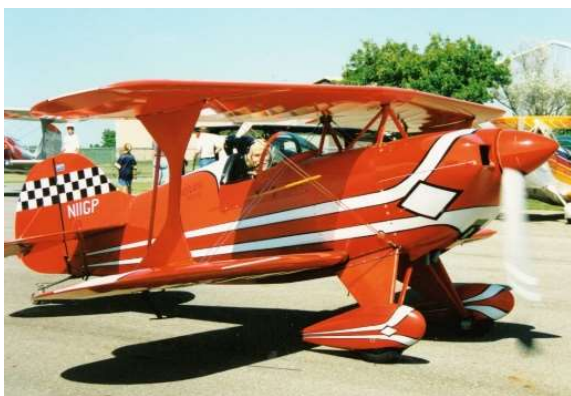
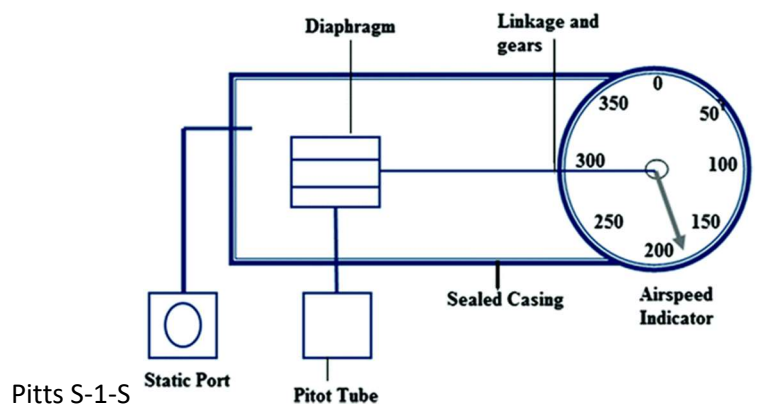
Airspeed System Component	Phase of Flight	Static Pressure		Static Air inside ASI Casing	IAS (mph)	TAS (mph)	
		p(S) Ambient	p(S) inside ASI Casing				
Static Port Blocked (but not totally closed) Pitot Tube Open	Ground - TO Roll	p(S) = GRD level	p(S) = GRD level	Static Air inside ASI Casing is equal to ambient air pressure	60	60	IAS = TAS Uneffected
	Climb [p(S) trapped air slowly leaking out of ASI casing]	p(S) = p(GRD) - delta p	p(S) = GRD level	Static Air inside ASI Casing slowly adjusting to ambient air pressure	< 100	100	IAS lagging TAS IAS reads slower speed
	Level Flight [after p(S) inside ASI casing has equalized]	p(S) = Altitude	p(S) = Altitude	Static Air inside ASI Casing has adjusted to ambient air pressure	150	150	IAS = TAS Uneffected
	Descent (ambient air slowly leaking into ASI Casing)	p(S) = Altitude + delta p	p(S) = Altitude	Static Air inside ASI Casing slowly adjusting to ambient air pressure	> 100	100	IAS higher than TAS IAS reads faster speed

Ground - Taxiing [p(S) still at about Traffic Pattern Altitude]	p(S) = GRD level	p(S) = TP Altitude	Static Air inside ASI Casing slowly adjusting to ambient air pressure	>> 10 (above 40 IAS)	10	IAS higher than TAS IAS reads faster speed

Since the phase of flight, that is most critical to maintaining control of the aircraft, is during the approach to landing, I evaluated the set of conditions that exist within the airspeed indicator system at that point of time. Having the ASI show a higher than actual airspeed during the landing phase can easily lead to stalling the aircraft, especially when turning base to final. The analysis in above table shows that the physical conditions in the airspeed indicator system, when considering the possibility of a blocked or partially blocked static port, will produce a higher than actual indicated airspeed.
