# Engine Oil Pressure and Prop Pitch - Sharing an Experience

by Hugo Ritzenhaler

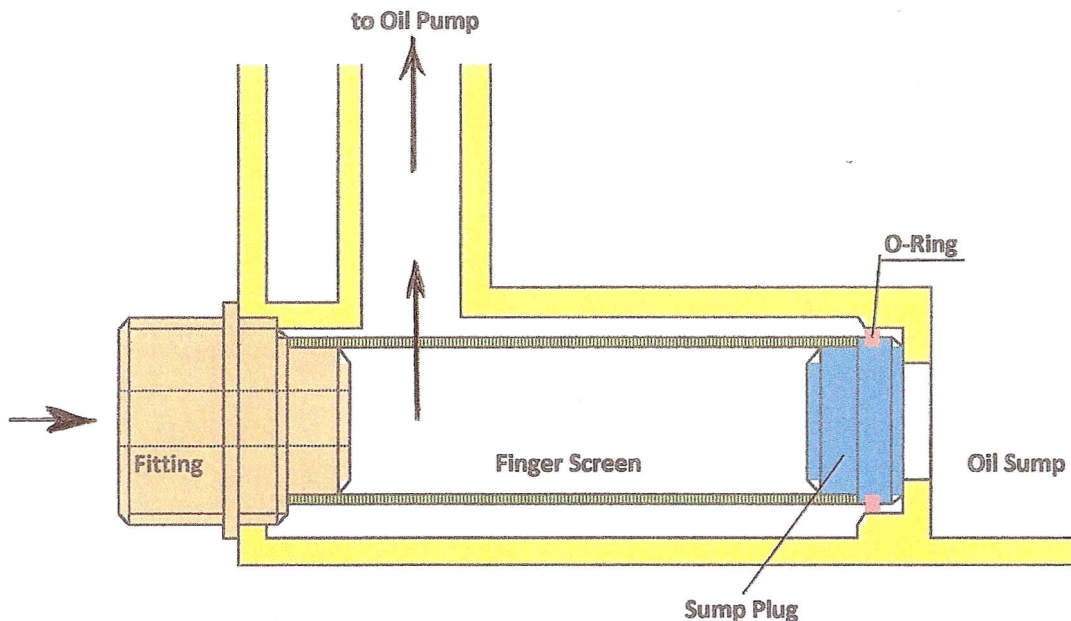
Finally, Doug pointed to the O-Ring, which is assembled to the sump plug at the far end of the finger screen (Fig 1).

Fig 1 - Sump Plug held in place by oil screen - correct screen length

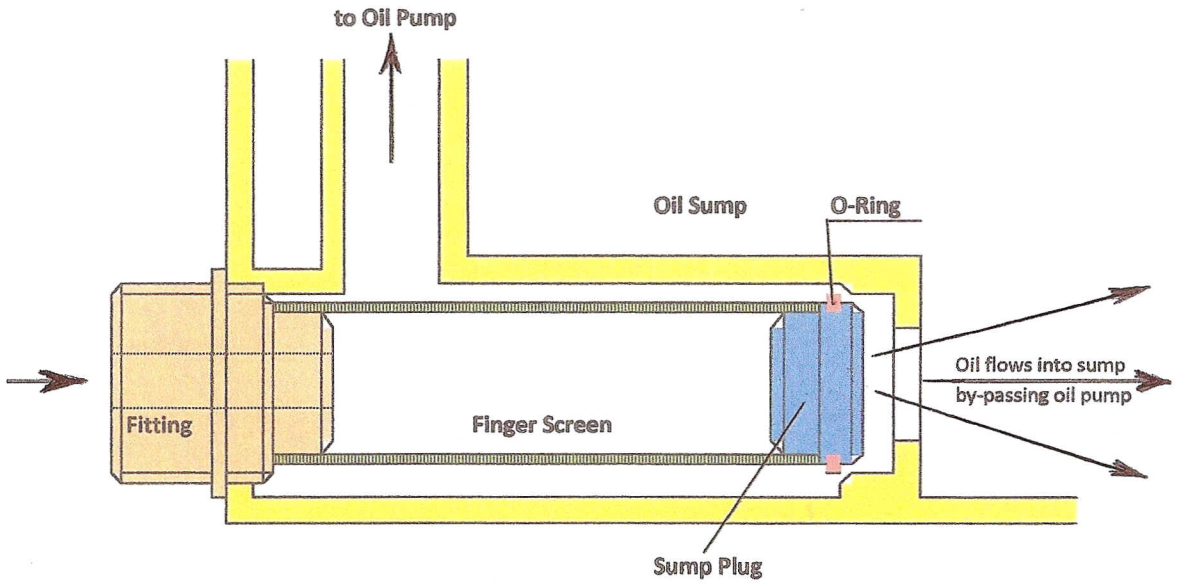
Back on the ground, removing fitting and screen, I re-inspect the position of the sump plug. To my surprise, the plug was again loosely positioned in the finger screen cavity. Something must allow the sump plug to move out of its place, the only way the oil could by-pass the channel to the oil pump (Fig 2). Oil by -passing the oil pump or leaking directly into the oil sump would certainly lead to a loss of oil pressure and subsequent drop in Engine RPM.

Fig 2 - Oil screen too short, Sump plug able to unseat

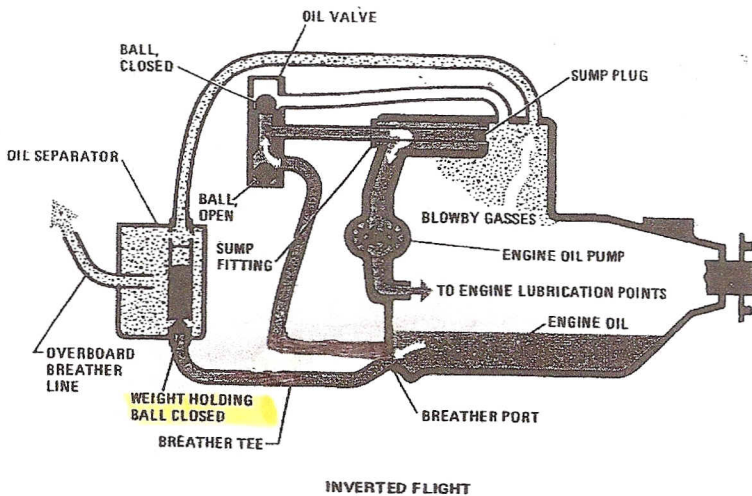
The hydraulic schematic of the engine in inverted flight provides a good picture of why there is little or no oil going to the oil pump if the sump plug were leaking.

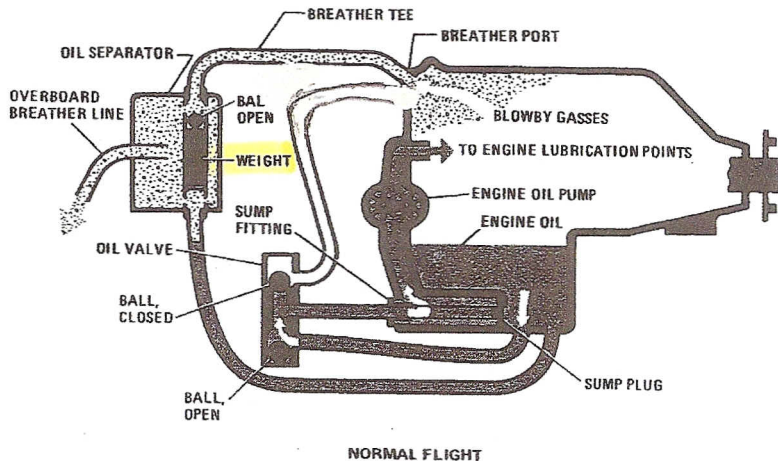
Any leakage at the sump plug would not affect oil pressure in normal upright flight as the oil pick-up is immersed in oil.

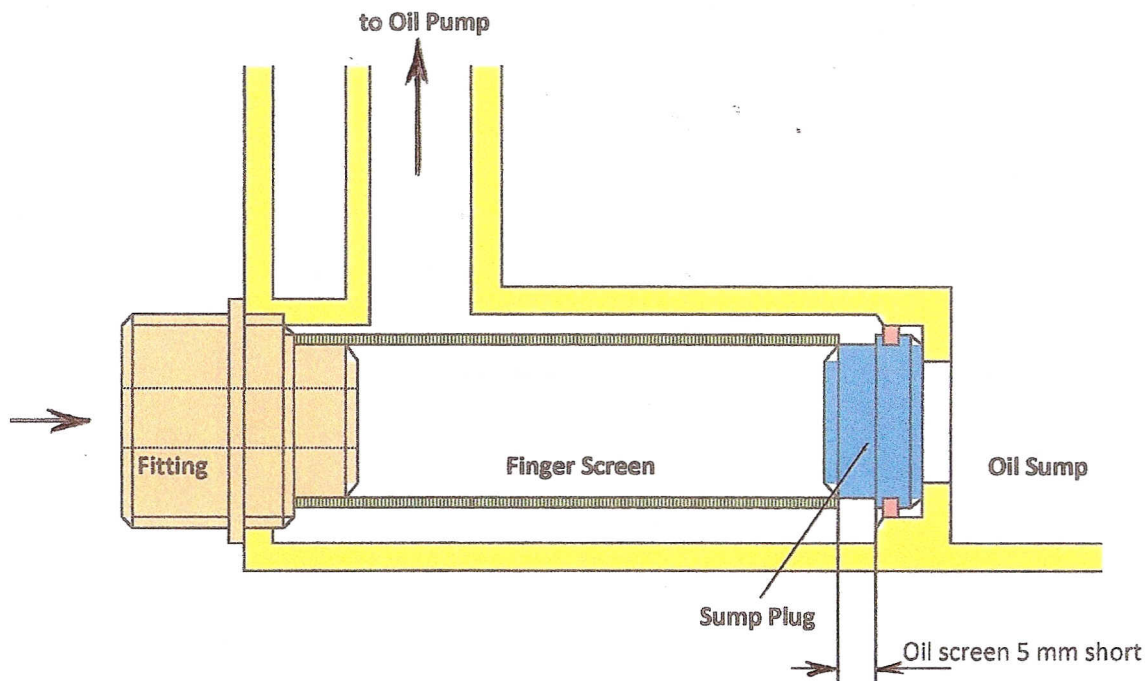
So why would the plug not stay in its position? After studying the design of the cavity, finger screen and sump plug, I started measuring all those components. It did not take long to realize that the finger screen was too short by about 5 mm (Fig 3). This discrepancy in length of the finger screen allowed the sump plug to move out of its cavity, rendering the O-Ring ineffective. This bleeding of oil directly into the sump reduced or completely stopped oil going to the oil pump to produce the necessary pressure to properly pitch the prop (move the prop to a fine pitch).

Fig 3 - Oil screen short by 5 mm

Once I understood the root cause, the problem was easily fixed. I got myself a longer finger screen, cut to length and reassembled plug, screen and fittings. The following test flight, during which many outside
