The Denton Flyer

Newsletter of EAA Chapter 661, Denton, TX

Being Advanced Isn't Always a Good Thing

by Russell "OB1" Erb

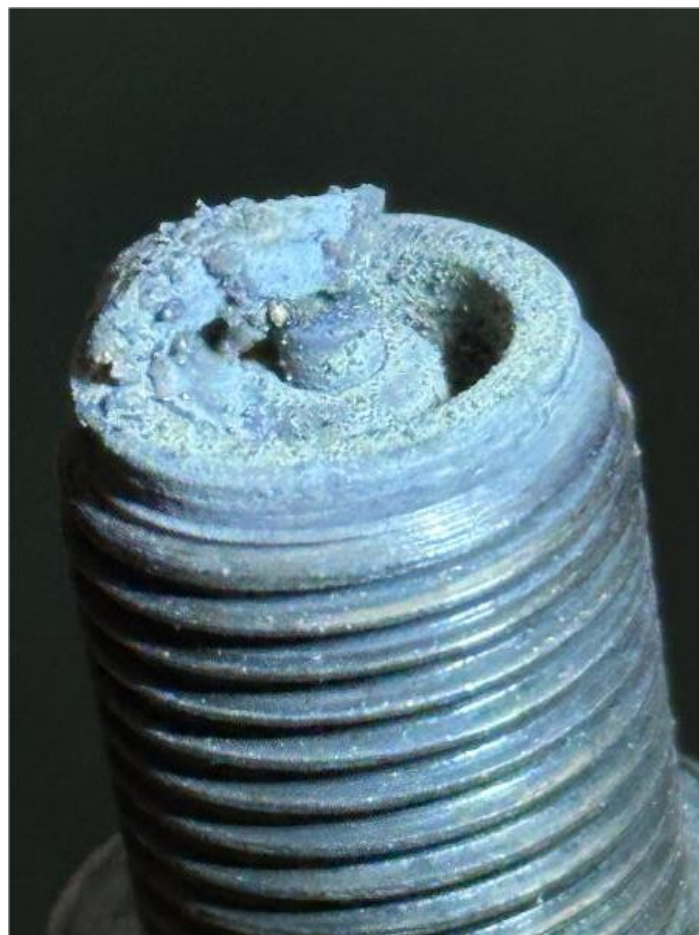
I posted the engine monitor data from the 23 December test flight to Savvy Analysis so that my analyst could see that everything was back to normal. To explain a sudden spike in the EGT trace, I mentioned to him that I had done an in-flight "mag check" at that point. Being the excellent analyst that he is, he looked at the traces to see if EGT increased when one of the ignitions was turned off. (EGT would increase because it takes longer for the whole fuel-air mixture to burn than when each spark plug only has to burn half of it. Because it takes longer, it hasn't cooled as much before going out the exhaust valve.) He noted that for one ignition, the EGT on cylinder #3 dropped when it should rise. He recommended that I check the spark plug for that ignition in cylinder #3. Since I didn't know which one it would be, I started with the lower plug, since I have only seen lead fouling on the lower plugs. Sure enough, the lower plug on cylinder #3 was heavily

fouled, as seen in these pictures. Rather than try to clean the plug, I simply replaced it with a new plug.
