Panther Building Log

TAIL FEATHERS & AFT FUSELAGE: February 2020 - March 2020

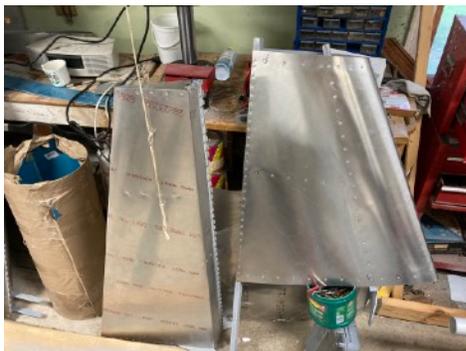
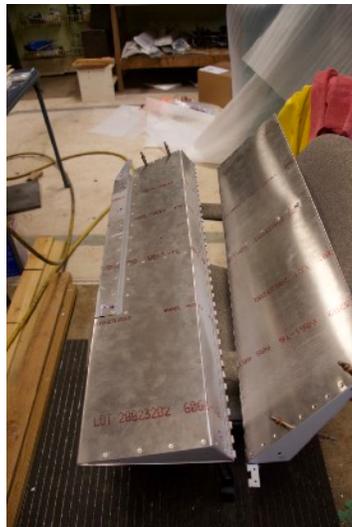
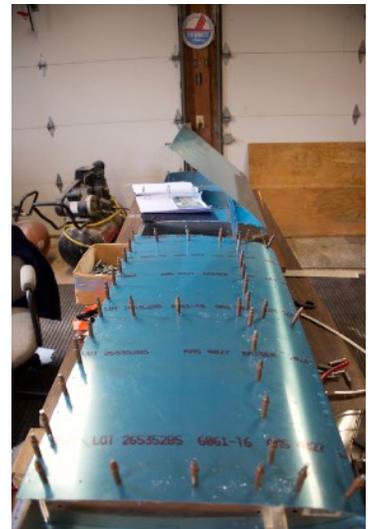
Work started in my garage doing the elevators first followed by the horizontal stabilizer, rudder, and vertical stabilizer. The hard part for me was getting the hinges attached properly, but at the end was success.

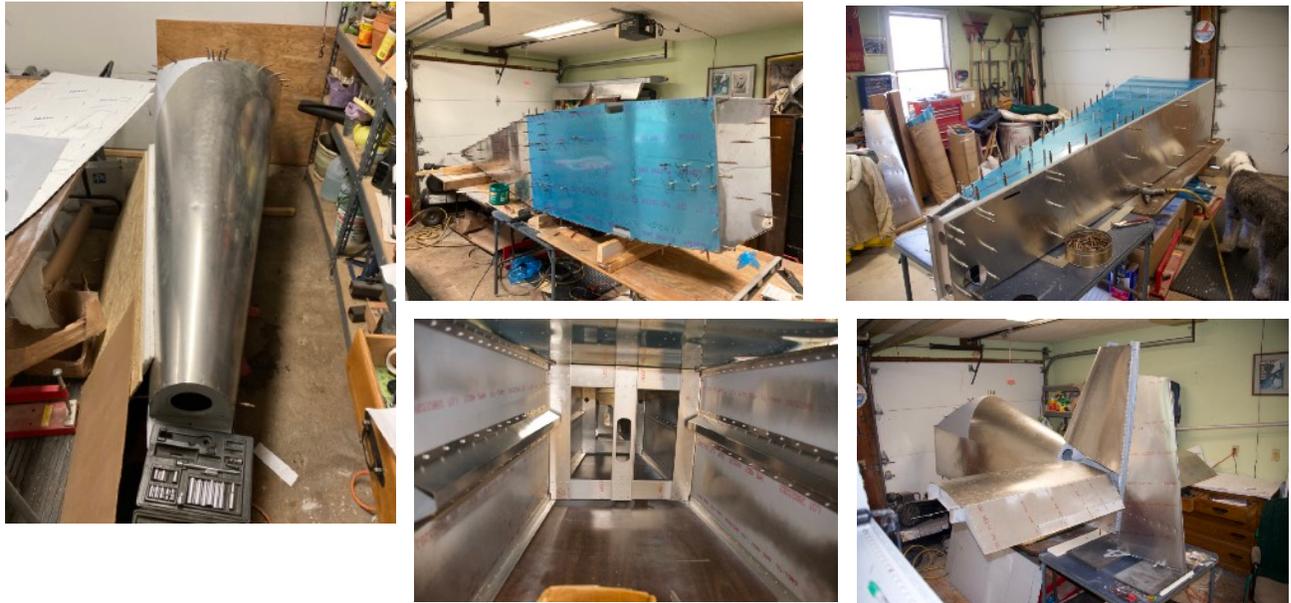
REAR FUSELAGE: March 2020 - May 2020

Starting in March 2020 the tail feathers and ailerons were complete, so I started on the rear fuselage. This process was straight forward, building the bulkheads first and then attaching the skins after drilling, de-burring, and dimpling. The building manual and plans were easy to comprehend, so this process moved on easily. Putting the tail feathers in place gave the impression of a real airplane. This part of the construction was complete in early May of 2020. I elected to use flush rivets on everything except for the forward fuselage as I did not want to compromise the square steel cage with dimples. Wings were delivered in May of 2020 which started the next phase of construction.

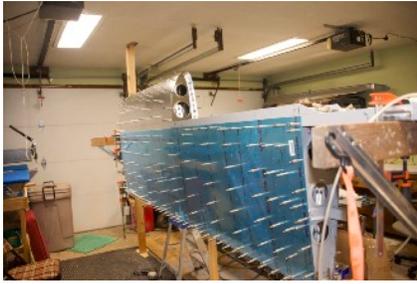
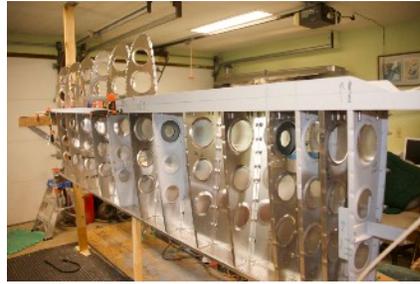
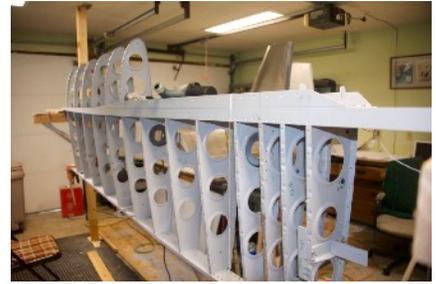
WING CONSTRUCTION: May 2020 - July 2020

This phase took longer than the other activities up to this point. Jigs had to be built in the garage and sorting out all the parts in order took a lot of time as all

looked alike. Thank God for the numbering system of the parts by SPA. Measuring for square and level on the jig was a challenge. I am glad I had the factory build the main spars and fuel tanks as it would have increased my building time a few months.

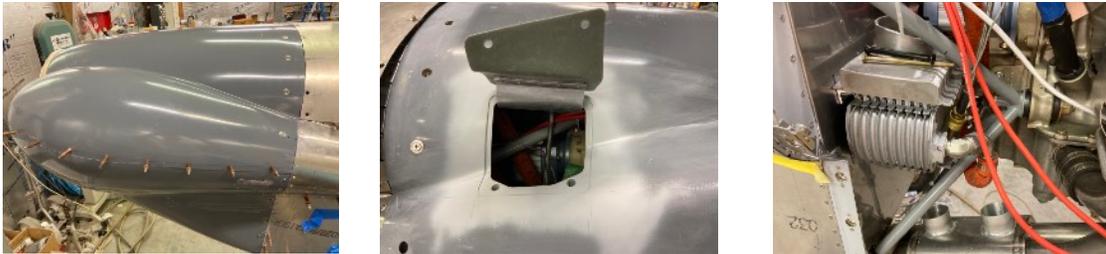
The cowling fitting was the most difficult so far. The top cowling was fit, but determined to have been cut too much at the bottom juncture and had to be replaced by the factory and fitted again - this time correctly. Also the canopy fiber glass fit around the front and rear had to be molded to fit. This was easier than anticipated.
