Oil Dipstick Leak – Sharing another Experience

By Hugo Ritzenthaler

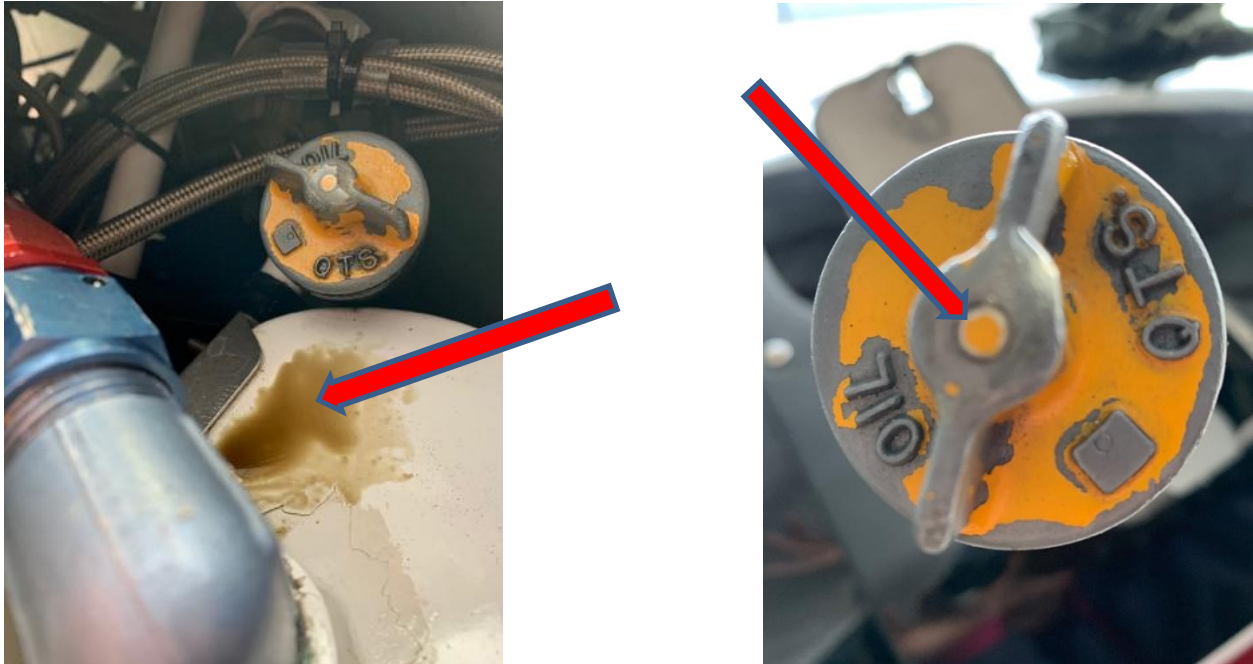
Going through the maintenance records of my Pitts S1E, I came across an anomaly that occurred on my Pitts S1E in 2015. Every time I checked the oil level, I noticed a small puddle of oil on top of the “slobber pot” oil separator tank that is located very close to the oil dipstick tube.

First I thought that the O-Ring on the dipstick needed to be replaced. So bought, what I believed was the correct size of the O-Ring and installed it. Still, after every practice flight, I found this small puddle of oil on the “slobber pot”. It seemed to be more severe, when flying outside figures. Next, I went back to the store to look for another size of O-Ring. Again, the slightly different O-Ring did not get rid of the leak. During my next flight up to Bay City I consulted with Doug Dodge of Acro Specialties. It did not take Doug much time to point to the loose rod in the dipstick flange. This tiny gap was large enough for the hot oil to seep through and end up on the “slobber pot”. Cleaning the dipstick before putting some epoxy in and above on the outside of the hole in the flange, where the dipstick rod is secured, fixed the problem. Since then, no more puddles on top of the “slobber pot”.
