## Fuel Tank Vent Line Leak – Sharing another Experience

By Hugo Ritzenhaler

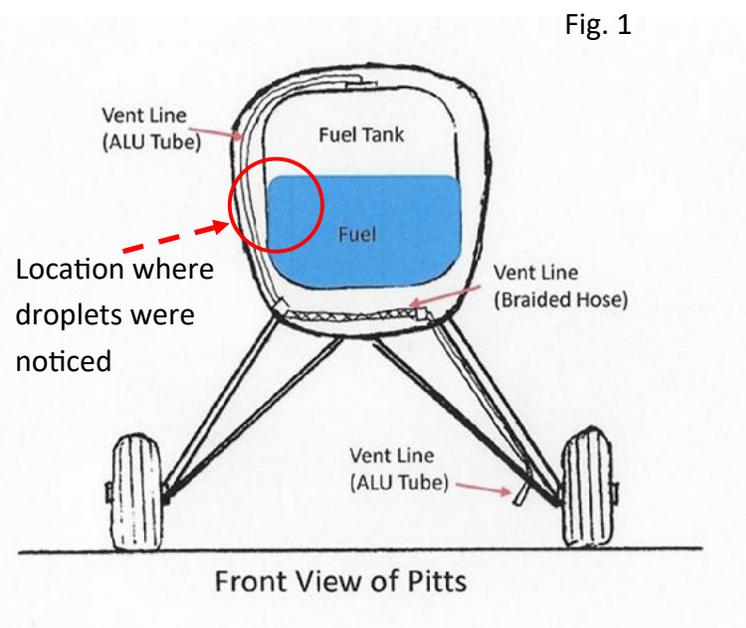
If those droplets were fuel, there had to be a leak somewhere in the cockpit close to the pilot seat. Furthermore, it had to be a function of the attitude of the aircraft. Since this Pitts did not have a header tank below the main tank, there were no other fuel carrying tubes and fitting, except for the vent line, that was located near the pilot seat. With the assistance of Doug Dodge, Acro Specialties, in Bay City, we took a look at the fuel tank vent line. Fig. 1 shows a cross section of the front of the Pitts. The vent line, an ALU tube, is routed from the top of the tank down the side to a fitting at the bottom of the cockpit. From there, a braided flexible tube connects to another ALU tube that is routed down the landing gear leg.

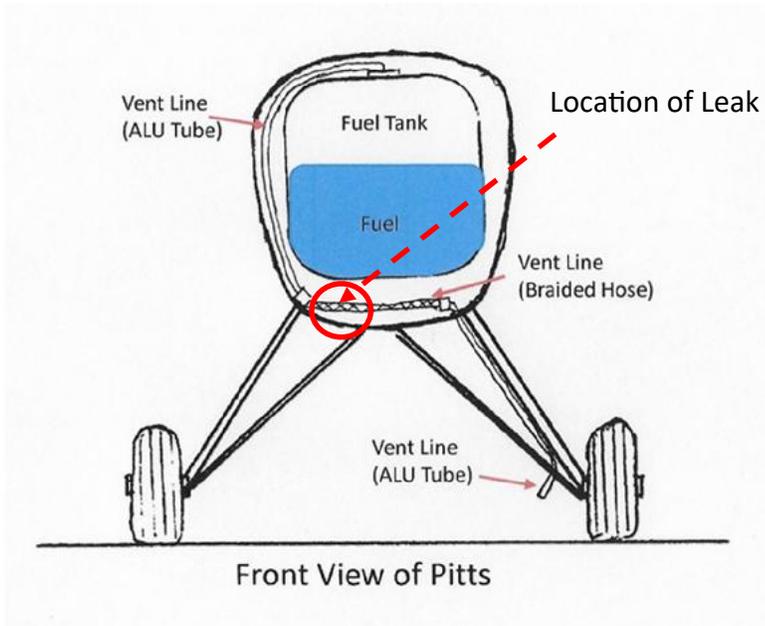
However, since most of the sprays that I encountered were at the top of a pull-push-pull Humpty (Fig. 6), it was this scenario to be closer looked at. Any fuel having entered the braided hose portion of vent line would see a force up toward the pilot when subjected to negative g's. A damaged flex hose would cause a spray upwards. At this point, the flex hose was removed and checked for a leak. Our assumption proved to be correct, there was a leak close to the right side of the cockpit.

That was the location the spray was noticed during the outside figures.

The braided flex hose was replaced with a fuel resistant clear plastic tube, which fixed this leak for good.
