The Denton Flyer

Newsletter of EAA Chapter 661, Denton, TX

Being Advanced Isn't Always a Good Thing

by Russell "OB1" Erb

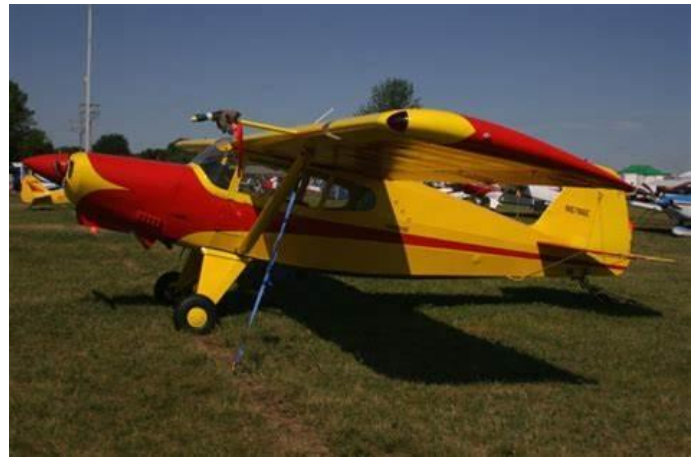
procedure. This procedure has been shown to work reasonably well in ambient air temperatures up to 100°F. Takeoff is done at maximum power with 2700 RPM to get to a safe altitude and airspeed as quickly as possible. While best rate of climb airspeed is about 75 KIAS, I always climb at 100 KIAS to give more cooling airflow over the engine. At an altitude high enough to turn back in case of an engine failure, usually between 500 feet and pattern altitude, I reduce the RPM to 2400. Reducing the RPM reduces the power produced and also reduces the excess heat produced. This procedure will usually keep the maximum cylinder head temperatures (CHT) between 400°F and 435°F steady state. Upon reaching cruise altitude, I reduce the RPM to 2100, which works well for economy while still at wide open throttle (WOT).

If all of the CHTs cool to around 360°F or below, I can close the cowl flap, which reduces drag an imperceptible amount. This will cause the CHTs to rise, with the happy zone being between 380°F and 400°F. This is cool enough to not worry, but hot enough to promote good lead scavenging.
