# Engine Oil Pressure and Prop Pitch - Sharing an Experience

by Hugo Ritzenhaler

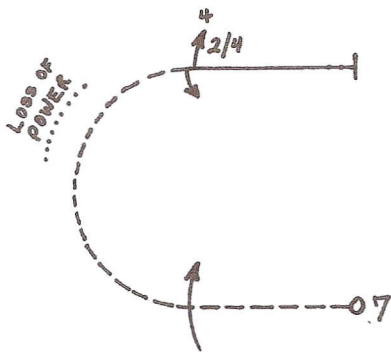
As I mentioned, I was attending the contest in Hanover. Since there were no other Unlimited pilots present, I competed in the Advanced category. Part of the known sequence was an outside half loop up from inverted (fig. 7). All went well during the known sequence until I was getting to the outside loop. Pushing up, getting past the vertical, I noticed a drastic drop in engine power and change in sound of the engine.

I managed completing the outside loop to level flight at which point the engine regained full power with oil pressure in the green. I interrupted the sequence and radioed the chief judge of my intention to land. Once on the ground, I ran up the engine, cycled the prop but could not reproduce the anomaly encountered during the outside loop. The safety committee reviewed my situation and decided to let me finish the sequence. I restarted the sequence with the figure prior to the outside loop. When I got to the push-up into the half outside loop, to my surprise, at about the same point into the figure, I noticed the exact drop off in engine power, which I had experienced during my previous flight. Since the power came back once I was on level flight, I finished the sequence without any further problems (there were no other outside maneuvers in this known sequence).
