NEWSLETTER

Carb Heat

Vol 30 No. 5

When Metal Lets Us Down
by Mike Busch

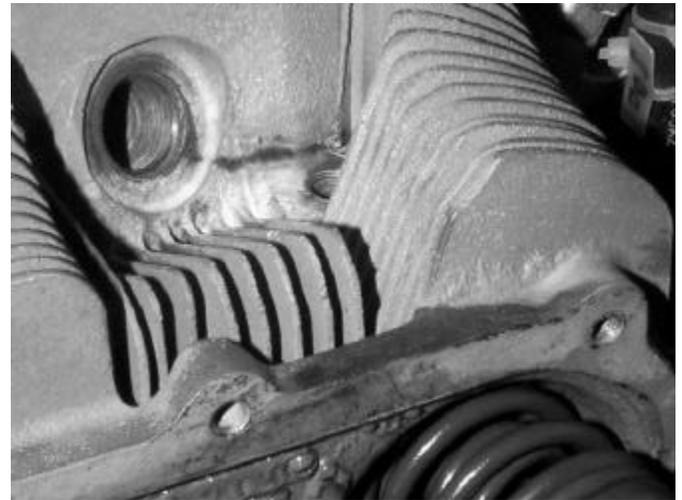
However, my interest in the subject was rekindled recently by a rash of maintenance problems I encountered with my 1979 T310R. The problems started showing up during my annual inspection last March. I did a compression check on my two 1000-hours-SMOH engines, came up with mid-to-high 70s on all twelve cylinders, and figured my jugs were doing just fine. But within an hour of starting the inspection, Phil Kirkham -- my IA for this year's ordeal -- called me over and pointed to a nearly imperceptible blue stain in the vicinity of the upper spark plug boss on the #5 cylinder of the right engine.

"One way to know for sure," Phil said, reaching for an aerosol can of dye penetrant. Within a few minutes, there was no question that Phil was right. The head was definitely cracked, and the cylinder was trash. This was something of a watershed event for me, since the twelve cylinders on my engines were the original twelve that rolled out of the Cessna Wallace Plant in 1979. They'd survived 20 years, 3,000 hours, and one major overhaul. But now, one of them had let me down. Could the other eleven be far behind?
