# EAA 857 NEWSLETTER

## BE AWARE OF CLOSED BOTTOM, OPEN-ENDED, UPTURNED TUBES

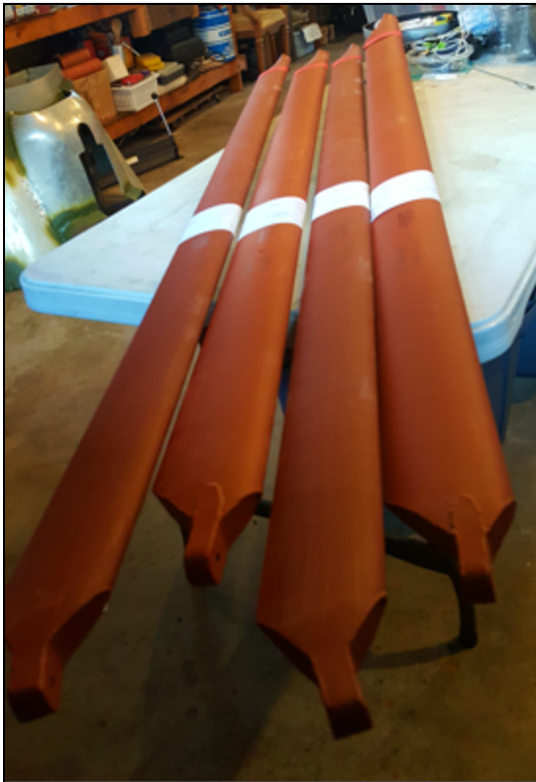
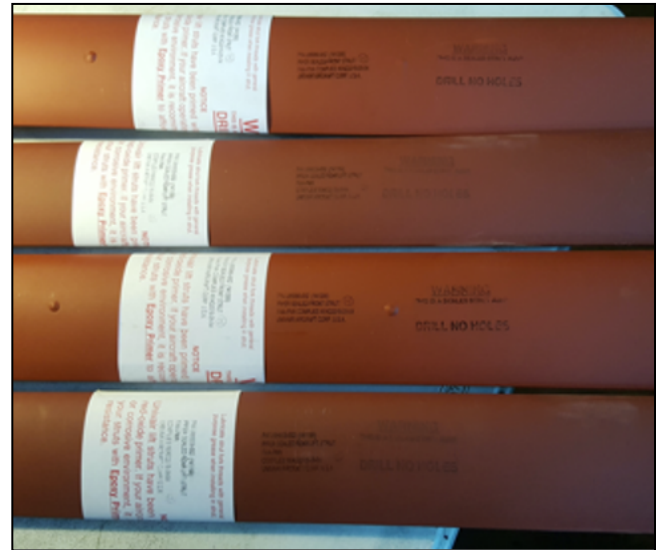
Figure 1 – High wing Piper lift sealed lift struts.  
Installation of these will terminate AD 99-01-05.

The FAA issued Airworthiness Directives (AD 99-01-05, and 93-10-06), entailing rigorous periodic inspections of the lift struts on all high wing Pipers. Replacement of the struts with new, redesigned, completely sealed units was an alternate means to comply with, and terminate, the periodic strut inspections required by the AD. See Figure 1, below.

The original design Piper wing strut is an example of a “Closed-bottom, open-ended, upturned tube” structure. This type of part is not extremely common, yet there are examples found on many airplanes. The history of the lift strut illustrates a potential hazard in these types of parts after years of service.

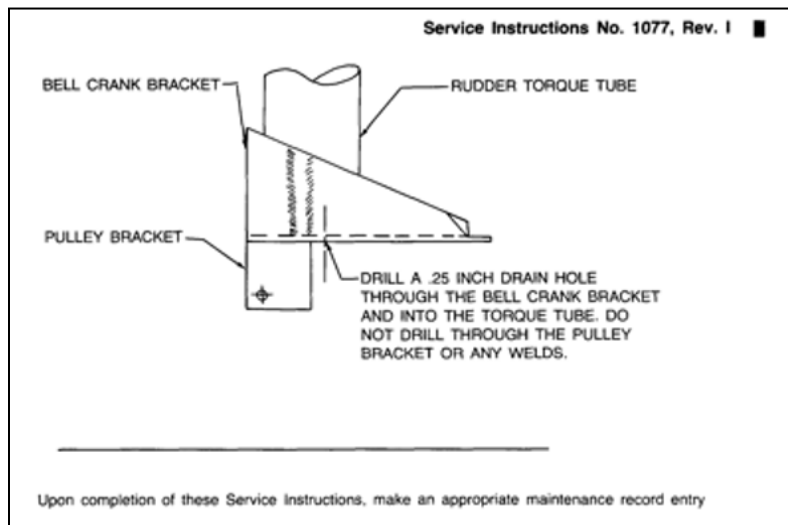
Figure 2. From Beechcraft Service Instruction to inspect rudder torque tube drain hole

As an example, Beechcraft Hawker has an active service instruction (SI 1077 – See Figure 2, below). This instruction is to inspect, clear out, and enlarge the drain hole found at the bottom of the rudder torque tube assembly on Baron aircraft, since it can entrap water and corrode internally if the hole is blocked. The same precaution could also be applied to several other airplane makes and models.

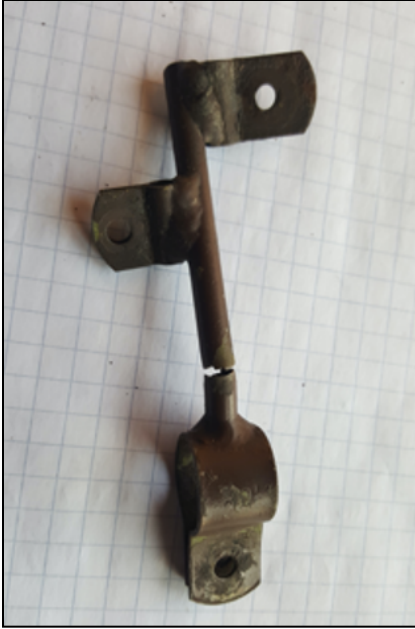
Fig 3. Throttle and mixture cable bracket assembly removed from light single engine airplane. The bracket tube has broken and separated near a clamp at the bottom of this photo, which attaches to the engine mount.

Another example is the welded steel tube bracket assembly, shown in Figure 3, below. It is a small, stationary bracket, to guide and stabilize the throttle and mixture control cables to the carburetor of a single piston engine plane. It is installed on the engine mount, near the carburetor beneath the engine. The bracket itself is an open-ended tube, which lives in a location where water can spray from the nose wheel, or rain droplets can impinge. The open mouth of this tube bracket, where the moisture can enter, is upturned.

Note that the bracket in Figure 3 has a jagged separation in the tube, where the end with two small cable clamps has parted with the base end. A magnified view of the fractured ends shown in Figure 4 reveals that the tube wall has corroded and thinned, significantly weakening the part. (This is exactly the same type of failure as in the Piper lift strut example, but on a much smaller part. Fortunately, this part did not fail in flight, but rather, it simply snapped off during an engine removal.)

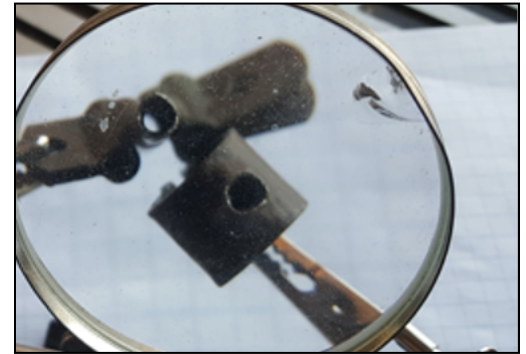
Fig 4. Magnified end view of the bracket tube where it fractured, showing how the tube wall has corroded internally and thinned noticeably.

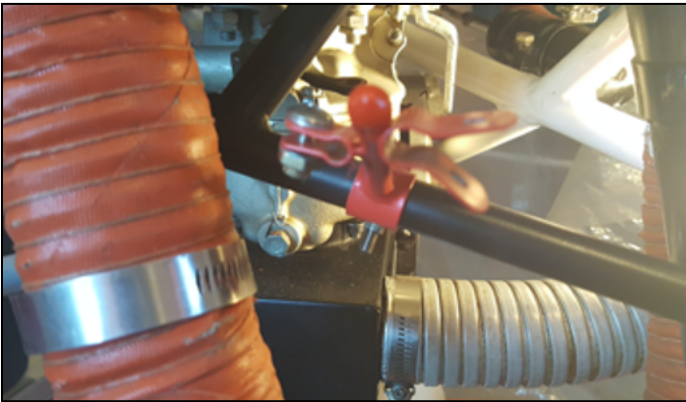
Figure 5. New replacement throttle and mixture cable bracket (painted red), installed on engine mount. The carburetor throttle arm can be seen beyond the right bracket clamp. The open-ended tube on the new bracket has been covered and sealed.

A replacement part was obtained and installed, as shown in Figure 5. However, the mechanic applied some sealant and a plastic cap on the tube mouth before installing it.
